NISSAN REPORT (summary)

Report made by Mr. S. Hanawa, Sr. Engineer, Equipment Check Engineering Group,
Engineering Experimentation Div., Third Engineering Dept.
Nissan Motor Co. Ltd., Kanagawa-Japan

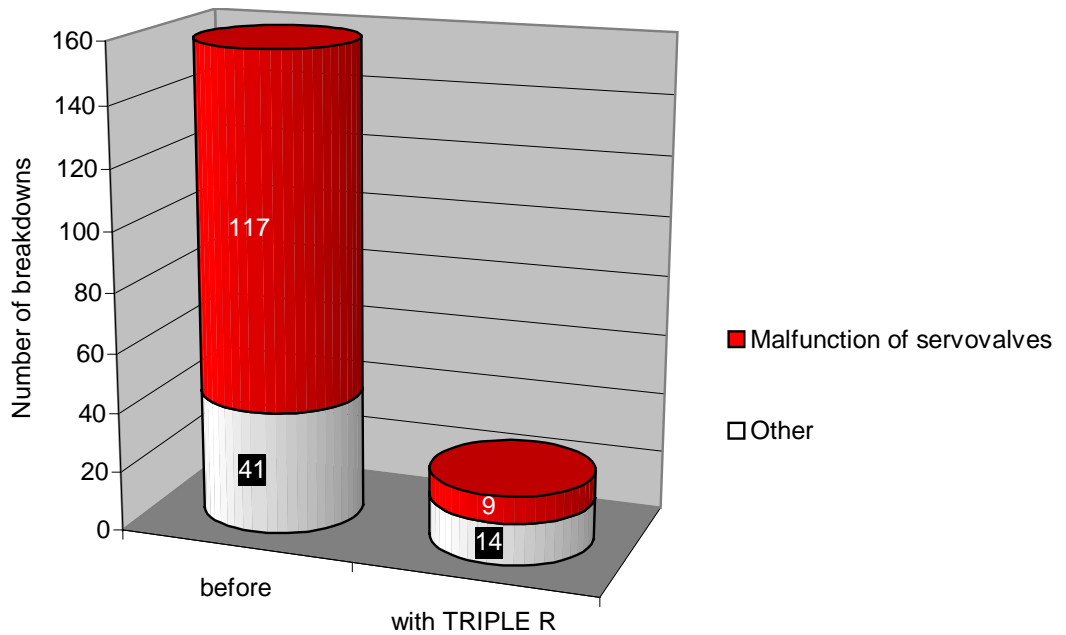
The results revealed :

Removal of contamination	93,3%
Reduction in machinery breakdowns	86,7%

Final results of the year-long study showed that installing off-line filtration systems reduced

- hydraulic breakdowns by **86,7%**
- failure of servovalves by **92,4%**
